## **STUDY ON CHANGE OF BUILDING STYLE AFTER EARTHQUAKE EVENTS**

### **Case Study: 2006 Borujerd Earthquake, IRAN**

Paper Reference Number: 0602-976

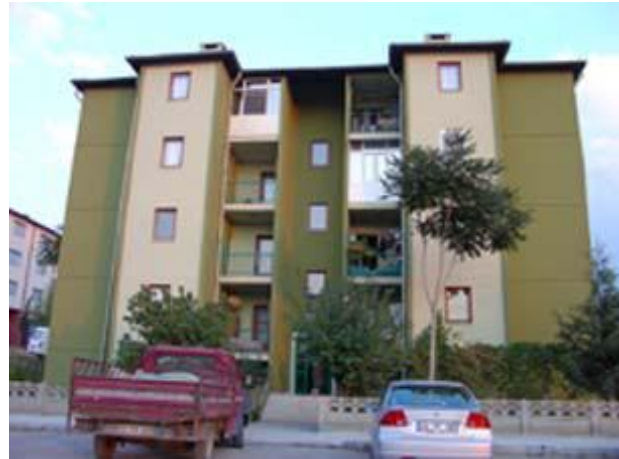
Fig. 1: Post Disaster Houses

Two types of post-disaster houses were reconstructed, first type has 4 stories and 16 flats (Fig. 1) and Second type also has 4 stories, 4 shops in ground floor and 6 flats in upper floors totally. With the new urban master plan of Dinar, instead of narrow, disordered, spontaneously developed streets within one or two stories, solid or hollow brick walled buildings with large gardens; new formed wide streets and four stories buildings constructed by tunnel mould system with small gardens, were organized.

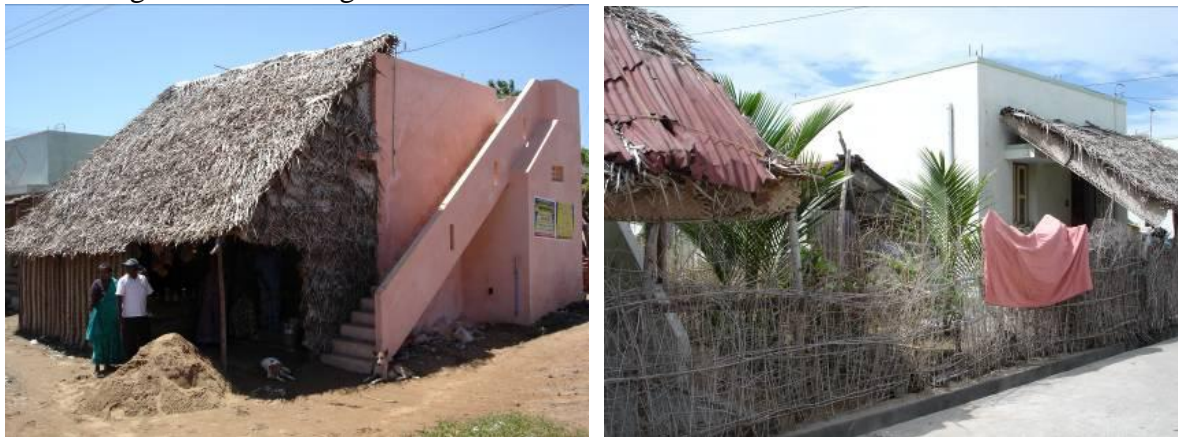
Fig. 2: Houses with vernacular materials

concrete block or mud brick, but the resulting new villages were foreign in many ways to the beneficiaries in their materiality and layout. 109 houses from 7 villages in the Tamil Nadu area of south east India and their modifications within the houses were surveyed and the results analyzed.

- Using vernacular materials with a feeling of sheltering;
- Using sheltering roof pattern;
- Providing shelter against the sun in tropical climate;
- Attention to climatic characteristic;
- Community involvement in the process of design and construction program.

(Russell, 2008). (Fig. 2)

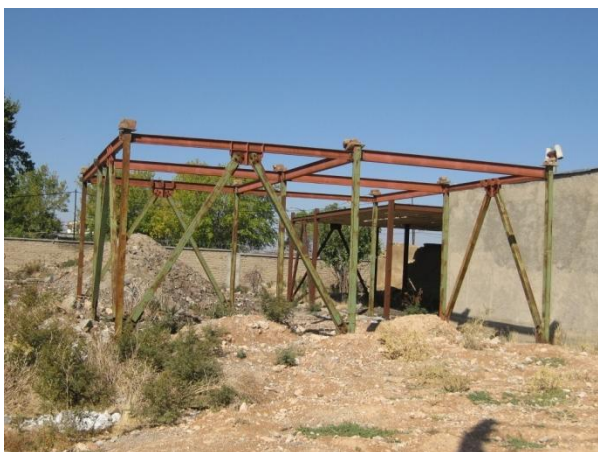
Fig.5: Pre-fabricated steel frame houses

But the earthquake event in these two villages was taken as an opportunity to do changes towards modern building style and modern life. People interviewed in these two villages expressed their desire for development and accepted the HF master plan as well as the modern single type of houses' plan, implementing eagerly. The master plan for the villages were designed in a modern style differ from their traditional ones, while the houses design was done in a single pre-fabricated steel skeleton type (Fig.5).

Doing the reconstruction process in the rural region affected by the earthquake in Lorestan, using pre-fabricated steel frameworks was dramatic change in a traditional and tribal-based community in the region. This caused total ignorance to traditional construction techniques and building materials. Speeding up the construction process may be true and useful in an earthquake stricken area, but the outcome should suit the long time life of the community. So, a modern construction style should not affect the long term life of the people in a negative way. It also may be true that a modern pre-fabricated steel framework could be more resistance and can sustain expected earthquake destruction, but it should also suit the continuance of the traditional life of the native people who used to live so for thousands of years. Change should be done in a moderate way, avoiding shocks may occur because of rapid reconstruction.

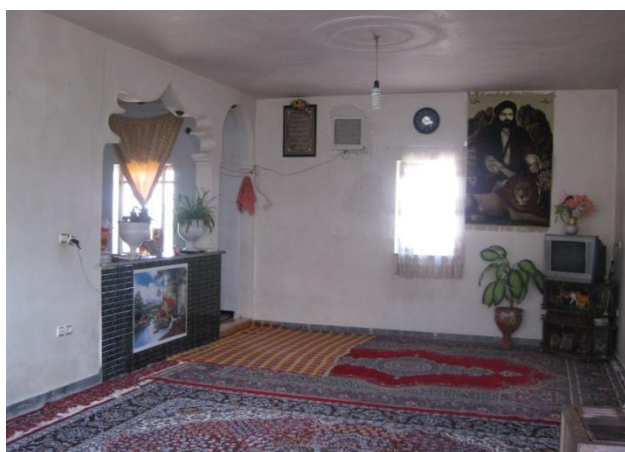
Fig.6: New houses design

life style for the families with open kitchen designed according to fashions available in urban houses in Iran (Fig.6).

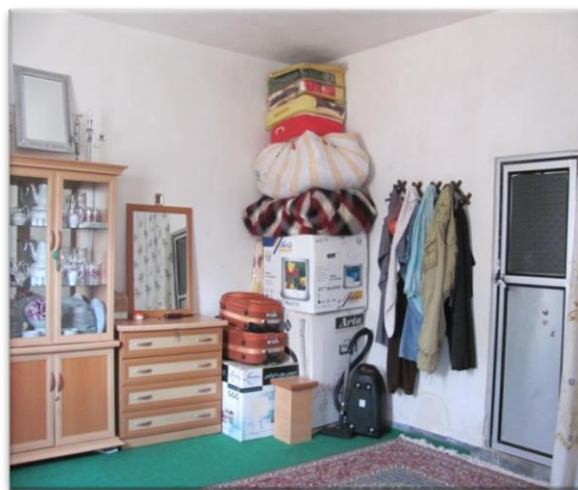
Fig.7: Store of stuffs

But changes went further affect their behavior style at their houses. Traditionally they used to put a store just behind their kitchens to store some stuffs needed mainly for cooking. Now, their new houses designed without such stores. The main problem occurs when they could not find a space for storing such stuffs, and disorder appears with loading their things in their sitting rooms (Fig.7)
